Manhole Inspection Summary

Manhole # S09CC2003MH

Insp Date: **7/18/06 8:19 AM**

Location Address: **2412 ROCKWOOD AVE**

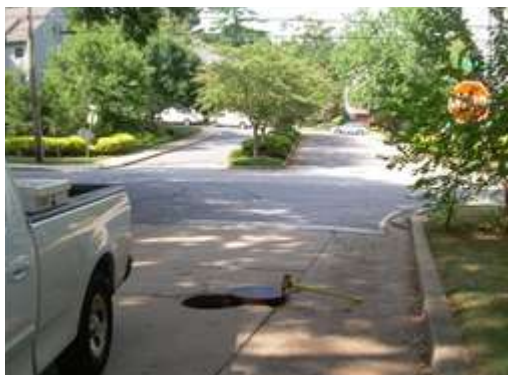
Location View

Comments **Cracks in pavement around manhole. Possible source of infiltration. I6 picture shows evidence of infiltration through the Barrel wall.**
